**Hazardous Materials Survey
Harford Senior Center
4920 Harford Road
Baltimore, Maryland 21214**

RRMM Architects
3700 Koppers Street, Suite 300
Halethorpe, Maryland 21227

EA Engineering, Science, and Technology, Inc., PBC
225 Schilling Circle, Suite 400
Hunt Valley, Maryland 21031
(410) 584-7000

June 2025
EA Project No. 16559-01-00

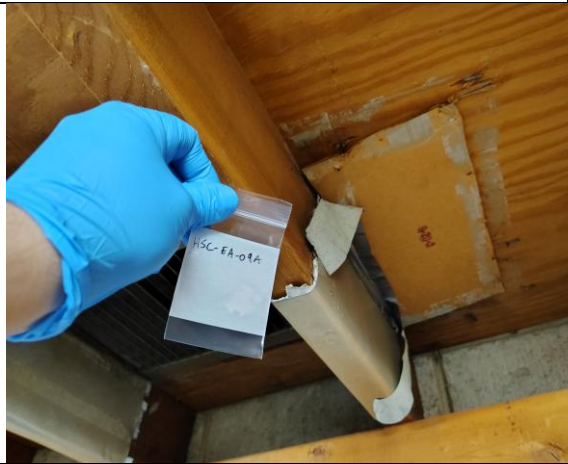
Gray Paper Wrap on Ceiling Joist
ACM – 50% Chrysotile

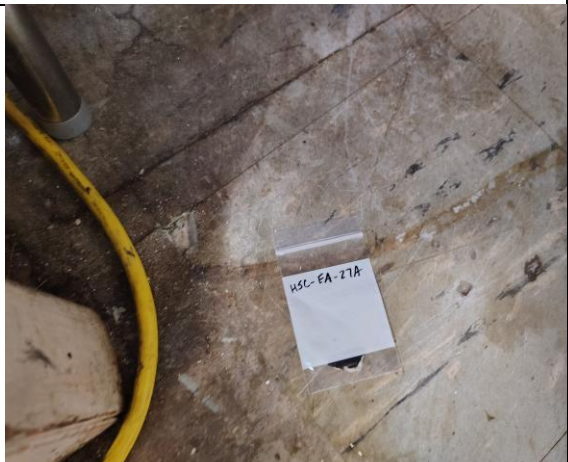
9" x 9" Gray Vinyl Floor Tile with Black Streaks
ACM – 3% Chrysotile

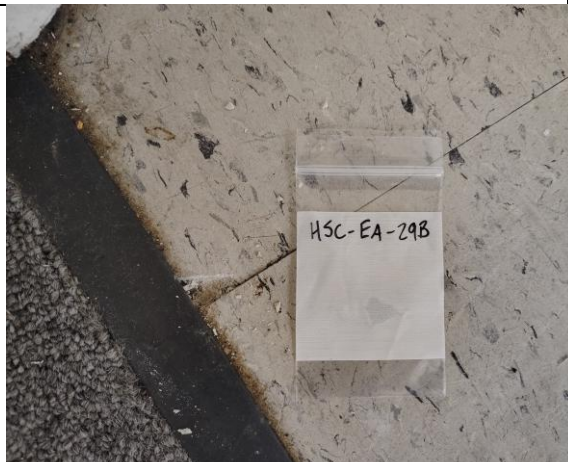
9" x 9" Light Gray Vinyl Floor Tile with Black and Gray Streaks
ACM – 3% Chrysotile

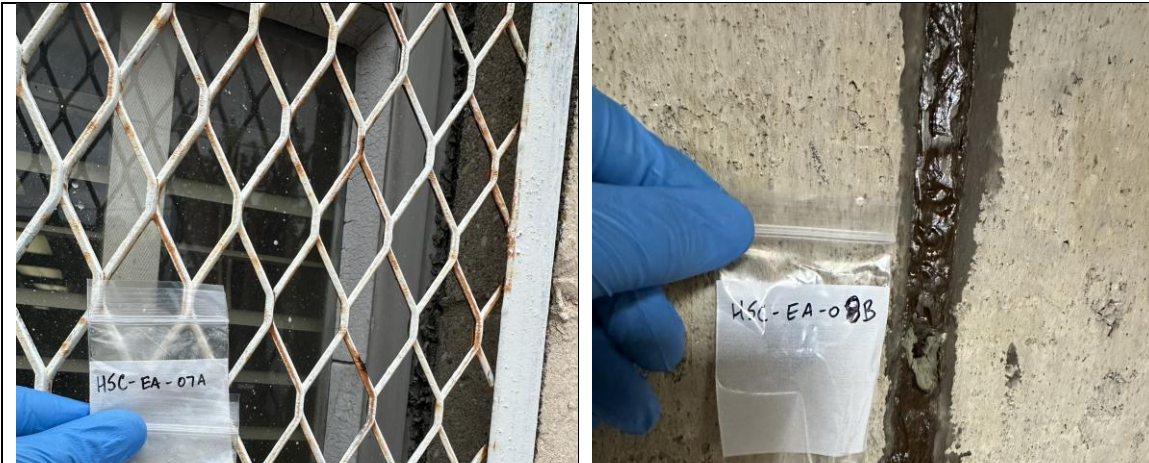
White Window Glazing
ACM – 2% Chrysotile

Black Expansion Joint
ACM – 5% Chrysotile

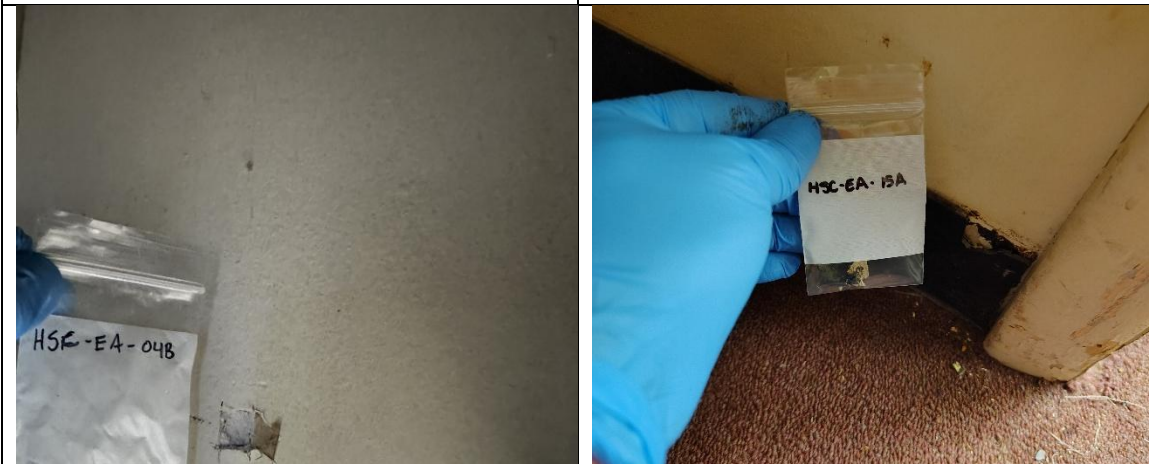
³ The quantity listed for joint compound is the estimated quantity of drywall observed at the building, as the joint compound cannot be economically separated from the wall system.

Joint Compound
ACM – 2% Chrysotile

Black Mastic Behind Black Covebase
ACM – 2% Chrysotile

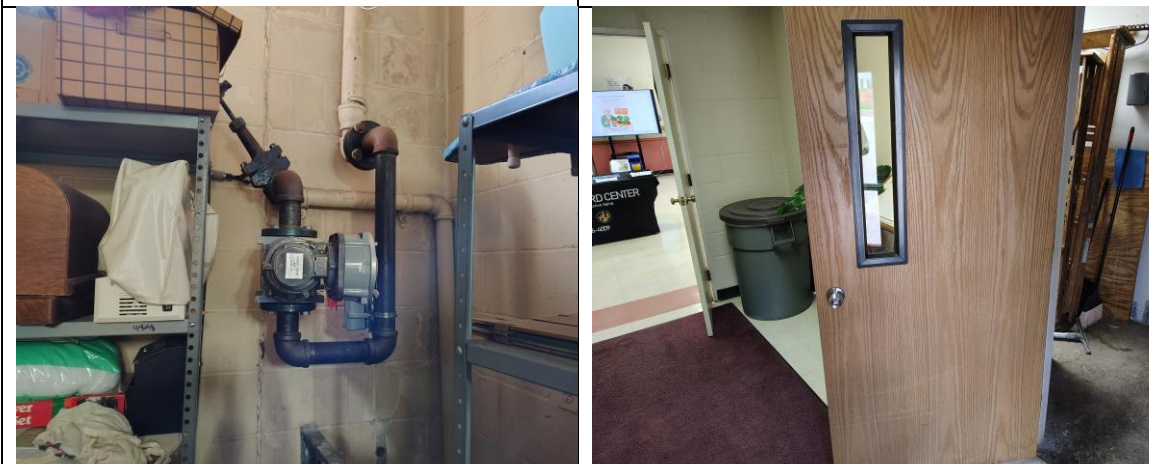
Assumed ACBMs include any material that is suspected to contain asbestos and that was not sampled. Pipe gaskets and fire doors were assumed to contain asbestos. These items were assumed to contain asbestos (rather than sampled/tested), as the materials were either inaccessible at the time of the survey or sampling would have caused damage to the structural integrity of the system while the facility is still in use.

The fire doors and pipe flange gaskets were assumed to contain asbestos, as the materials were either inaccessible at the time of the survey or sampling would have caused damage to the structural integrity of the system while the facility is still in use. It may be cost effective to have these assumed asbestos-containing materials sampled and analyzed at an appropriate time so that asbestos content can be determined. The most appropriate time to sample these materials is typically after the project has been turned over to the renovation contractor and work has commenced.

Pipe Flange Gasket
Assumed ACM

Representative Fire Door
Assumed ACM

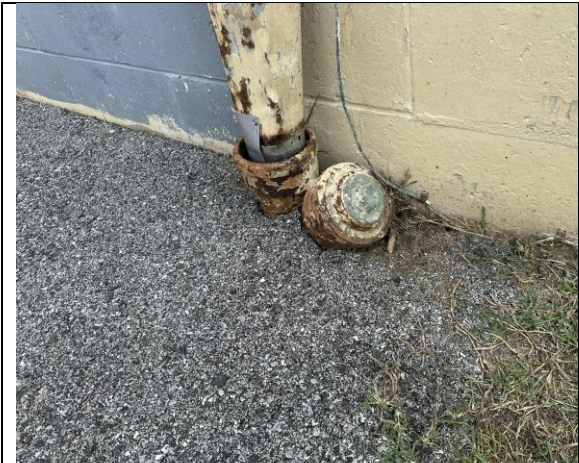
Reading #191 - Exterior Pipe
Lead-Based Paint

Demolition debris with LBP and lead-glazing may be disposed of as non-hazardous provided the material is not classified as a hazardous waste in accordance with 40 CFR Part 261 and SW-846 (Test Methods for Evaluating Solid Waste Physical/Chemical). Metal objects coated with LBP and the lead pipe can be recycled.

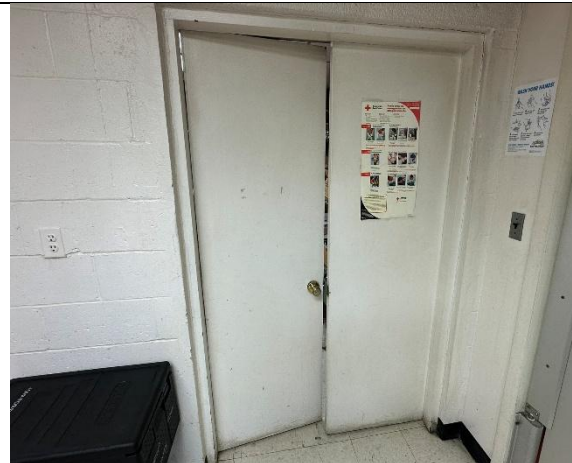
Readings #52 & 53 - White Door and Door Frame
Lead-Based Paint

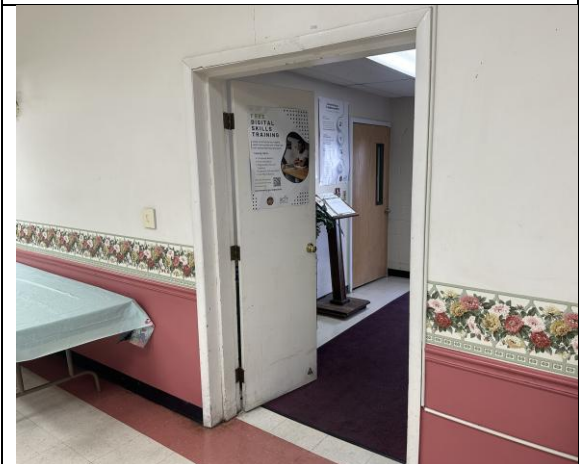
Reading #27 - White Door Frame
Lead Based Paint

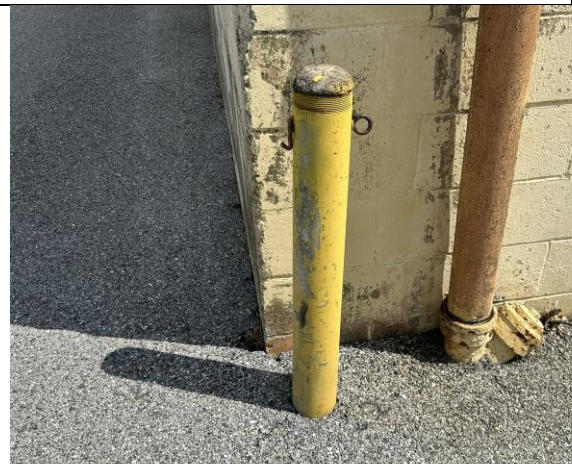
Reading #195 - Yellow Parking Bollard
Lead-Based Paint

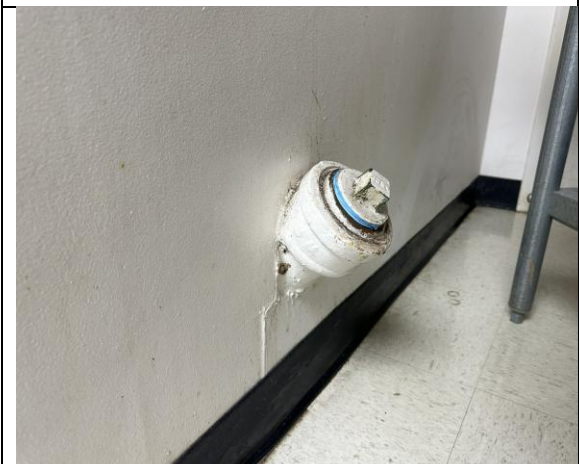
Reading #59 - White Pipe
Lead-Based Paint

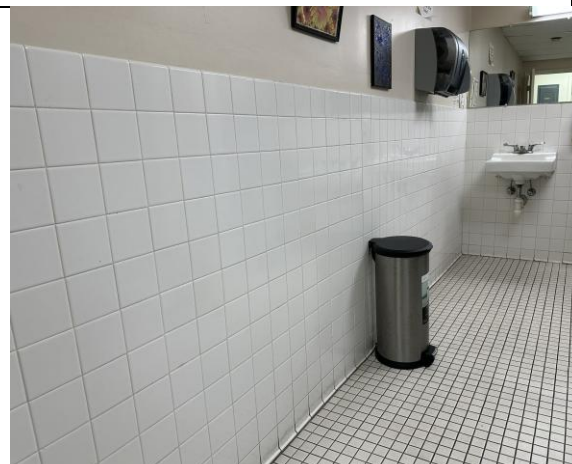
Readings #84 & 85 - White Ceramic Tile
Lead in Glazing

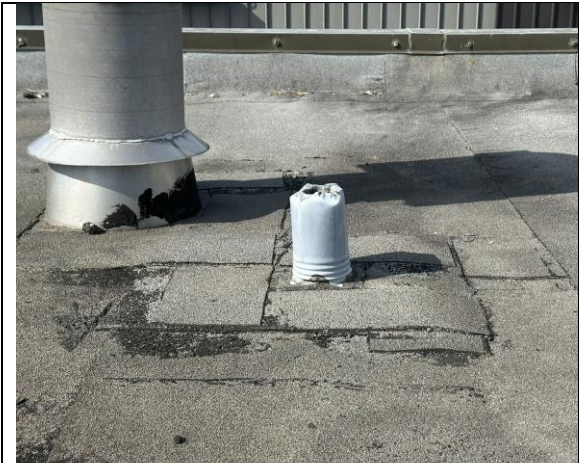
Reading #7 - Roof Pipe
Lead Pipe

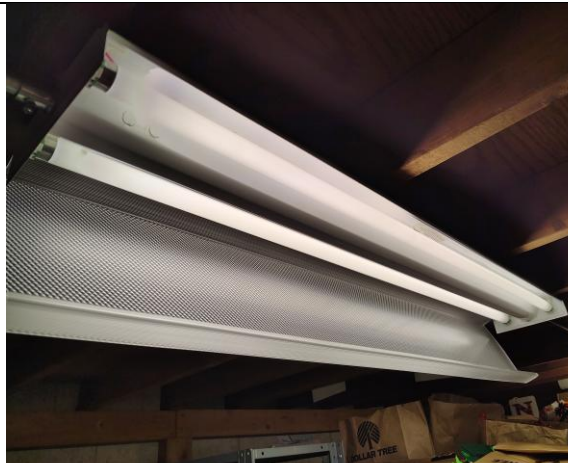
Fluorescent Light Ballast
Assumed PCB-Containing Equipment

Ballasts marked as "No PCBs" can be disposed of as non-hazardous waste. Ballasts lacking the "No PCBs" mark should be removed and disposed of in accordance with EPA's Toxic Substances Control Act (TSCA), 40 CFR Part 761. If an unmarked ballast is not leaking, the associated lighting fixture does not require special handling or disposal. If an unmarked ballast is leaking, any material impacted by the leak should be treated as hazardous waste. Containers storing unmarked ballasts must be labeled in accordance with EPA labeling requirements specified in 40 CFR Part 262 Subpart C.

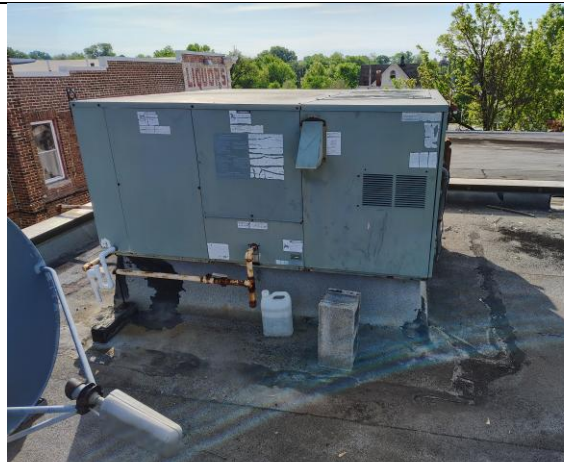
Rooftop Air-Condensing Unit
Assumed ODS-Containing Equipment

Under EPA's rule, refrigerant must be recovered from equipment that is typically dismantled on-site before disposal (e.g., retail/commercial food refrigeration, central air-conditioning, chillers, and industrial process refrigeration) in accordance with the EPA's requirements for servicing.

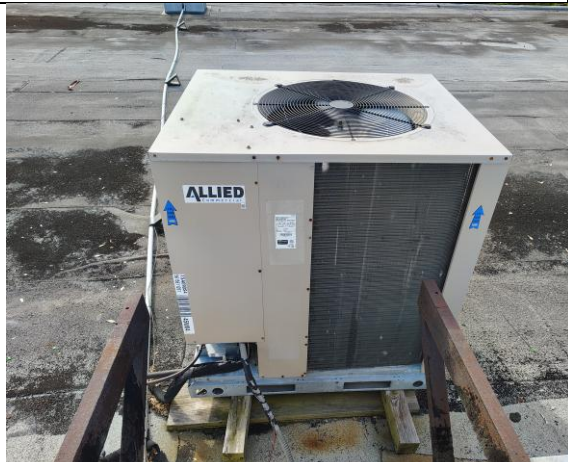
Representative Rooftop Air-Conditioning Unit
ODS- Containing Equipment

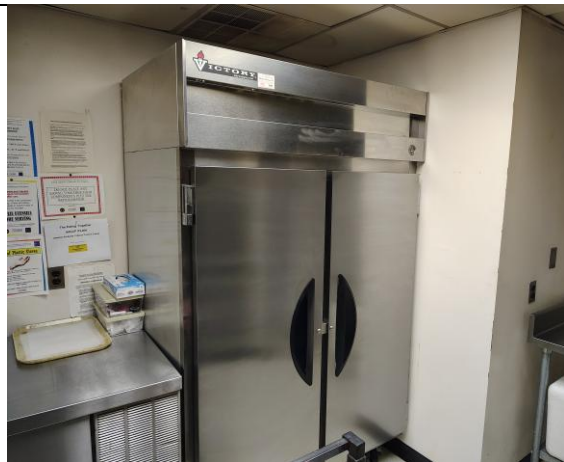
Representative Commercial Refrigerator
Assumed ODS-Containing Equipment

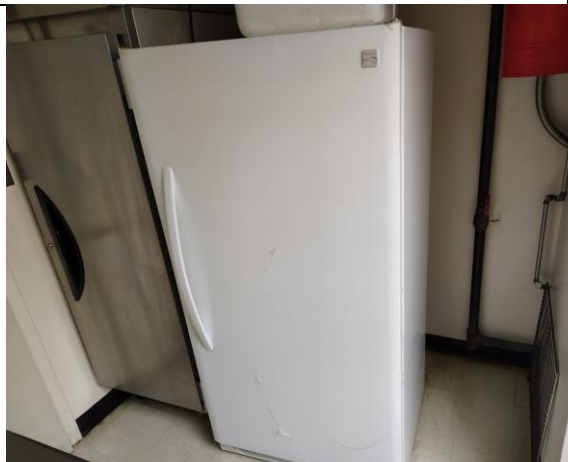
Household Refrigerator
Assumed ODS-Containing Equipment

Equipment that typically enters the waste stream with the charge intact (e.g., household refrigerators, motor vehicle air conditioners, household freezers, and room air conditioners) is subject to special safe disposal requirements. Under the safe disposal requirements, the final person in the disposal chain (e.g., a scrap metal recycler or landfill owner) is responsible for ensuring that refrigerant is recovered from equipment before the final disposal of the equipment. However, persons "upstream" can remove the refrigerant and provide documentation of its removal to the final person if this is more cost-effective. If the final person in the disposal chain (e.g., a scrap metal recycler or landfill owner) accepts appliances that no longer hold a refrigerant charge, that person is responsible for maintaining a signed statement from whom the appliance(s)

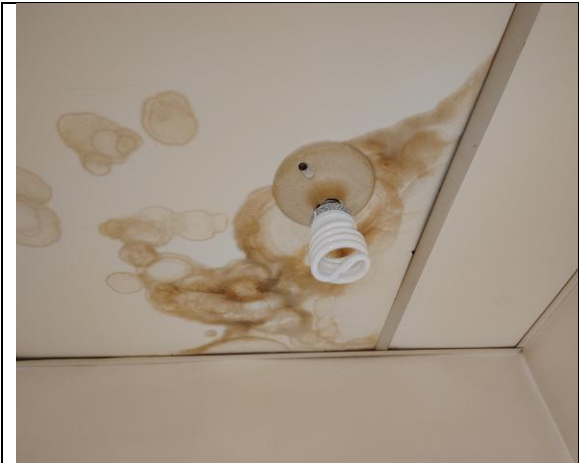
Compact Fluorescent Light Bulb
Universal Waste

All universal waste impacted by planned renovation activities should be placed in a container that is structurally sound, will prevent damage to the contents, is compatible with its contents, and will be kept closed at all times (except when adding items to or removing items from the container). The container must be without damage, or evidence of spillage, that could lead to leakage of the waste contained inside. The disposal of universal waste is outlined in the EPA regulations in 40 CFR Part 273 and in Maryland regulations in COMAR Title 26, Subtitle 13.

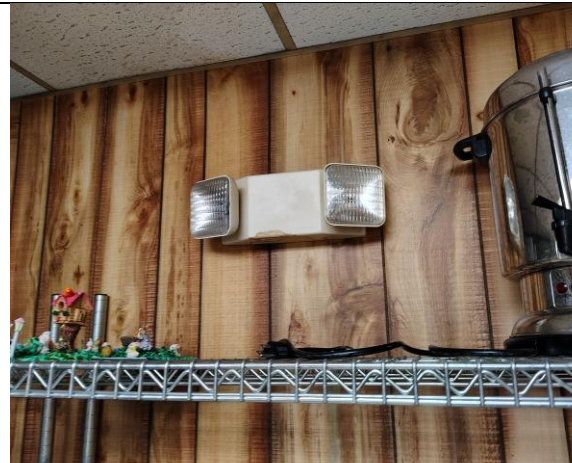
Representative High-Intensity Discharge Bulb
Universal Waste

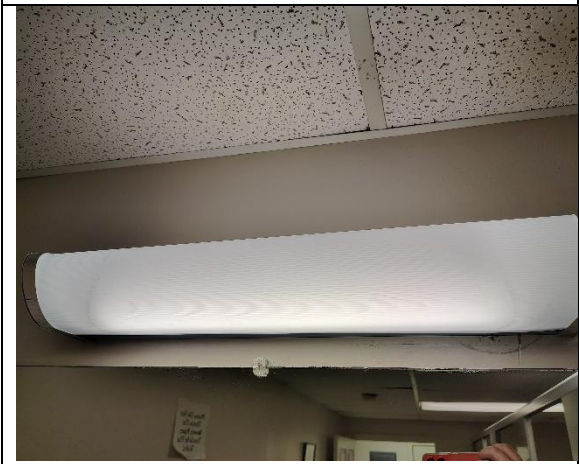
2' Fluorescent Light Tube
Universal Waste

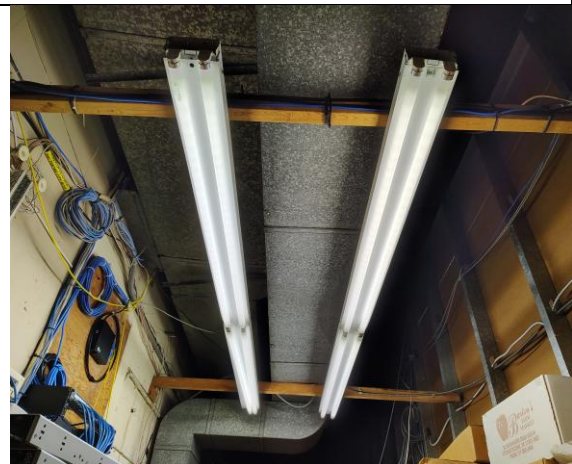
Representative 4' Fluorescent Light Tube
Universal Waste

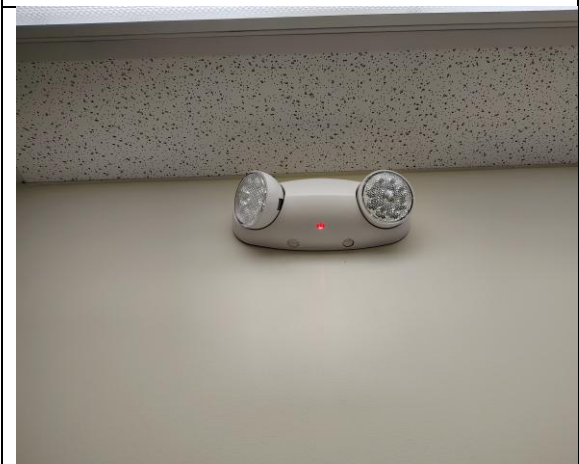
Representative Battery Inside Emergency Light Fixture
Universal Waste

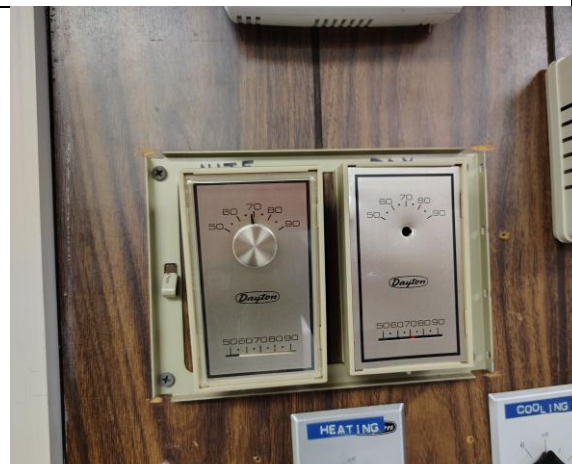
Mercury-Containing Thermostats
Universal Waste
